Restoring the Lion's Roar: Documenting and Replicating Limestone Structures Through Laser Scanning, 3D Computer Modeling, and CNC Machining

This lecture was presented at the [3D Digital Documentation Summit](#) held July 10-12, 2012 at the Presidio, San Francisco, CA

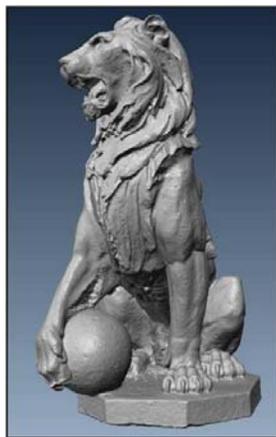
In January 2011, Kreilick Conservation, LLC of Oreland, PA was engaged by Beaver Electric Co. Inc. to conserve the Branch Brook Park Prudential Lions. The Prudential Lions, sculpted by Karl Bitter (1867-1915), were installed over the doorway of the Prudential Insurance Company, Newark, New Jersey, in 1901. After the building was demolished, the Lions were installed in Branch Brook Park, Newark, New Jersey in 1959. In August 2011, after conservation work had begun on the sculptures, Kreilick Conservation was engaged by the Branch Brook Park Alliance to create full-scale replicas of the Lions. To complete the work, Kreilick Conservation put together a team of 3D documentation professionals, including Direct Dimensions, Inc., who undertook laser scanning and 3D computer modeling, and the Digital Atelier, LLC, who used the models for CNC machining foam. The Prudential Lions are carved limestone companion sculptures depicting seated male lions, each with a front paw resting on

a sphere (see Figure 1). Each lion sat atop a concrete base. The bases originally had inscribed plaques which read, "Presented to the citizens of Essex County/by the Prudential Insurance Company of America/from 1892 to 1958, more

than half a century, this lion, with/its twin companion, sculpted by Karl Bitter, stood guard/over the doorway of the First Prudential Building in Newark/at 763 Broad Street, corner of Bank Street. They have witnessed/the growth of Newark from a town to a metropolis.” The Lions are approximately seven feet tall and weigh 2,900 pounds each.

So here are the lions as we first met them. Their carved limestone companion sculptures depicting seated male lions with a front paw on a sphere. They are approximately seven feet tall and weigh about 2900 pounds each. Before treatment the limestone exhibited staining, biological growth, gypsum crust, graffiti, scratchitti, mechanical damage, spalling and erosion of details. There were missing portions of their tails, teeth, claws, ears, manes, snouts, etcetera, etcetera. On top of all of this, to cover these conditions, at some point, someone decided to take as a maintenance intervention, painting of the lions, which gives them sort of this modeled tannish appearance that they have here.
